FINAL REPORT  
ADVANCED THERMOPLASTIC COMPOSITE DEVELOPMENT  
CONTRACT N00019-77-C-0561

NAVAL AIR SYSTEMS COMMAND  
U.S. DEPARTMENT OF THE NAVY  
Washington, D.C. 20360

Boeing Military Airplane Development Organization  
Boeing Aerospace Company  
Seattle, Washington 98124

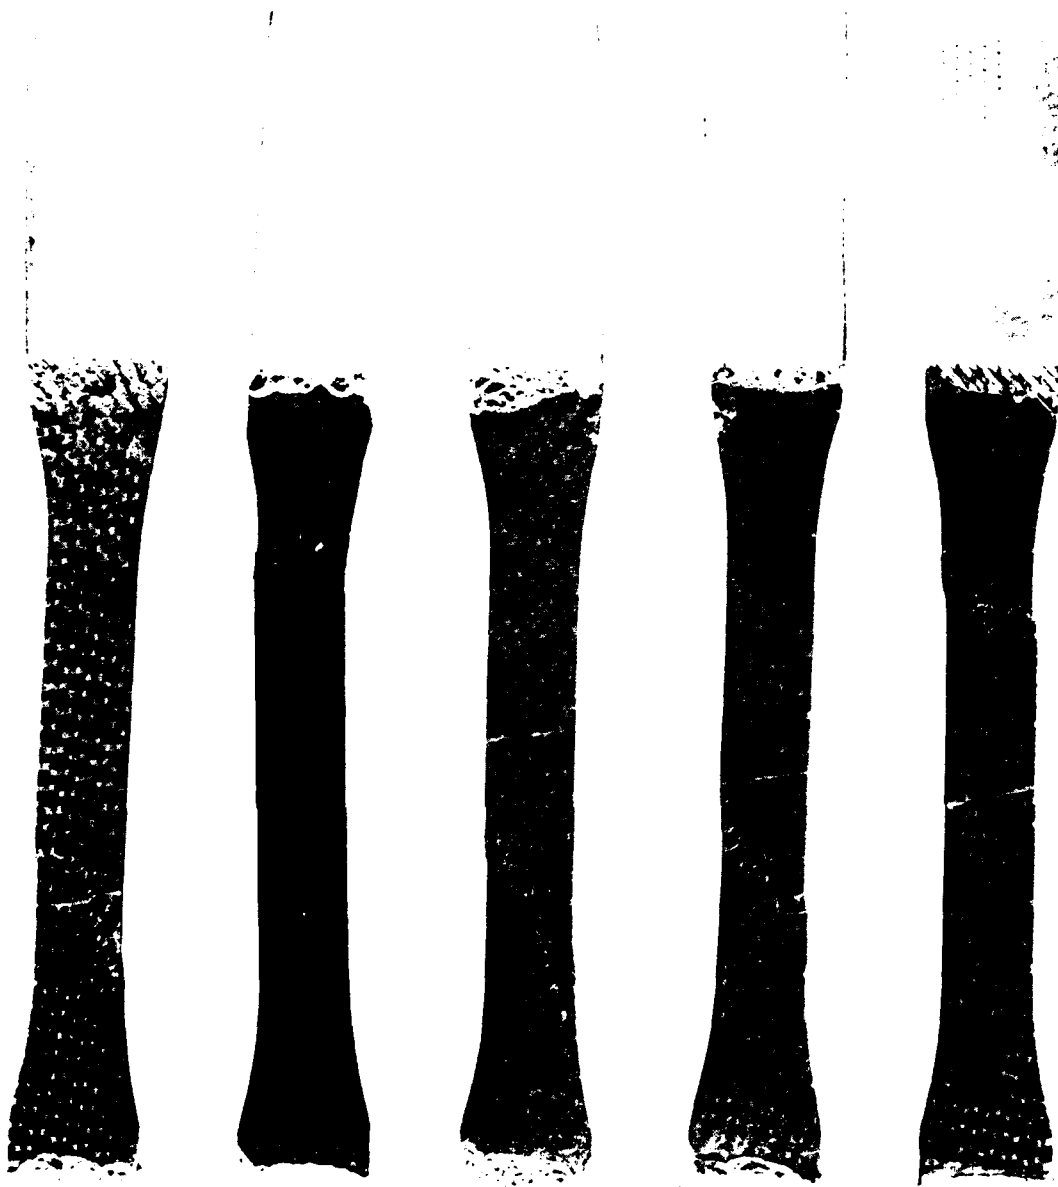
Figure 24: TENSION SPECIMENS AFTER TEST

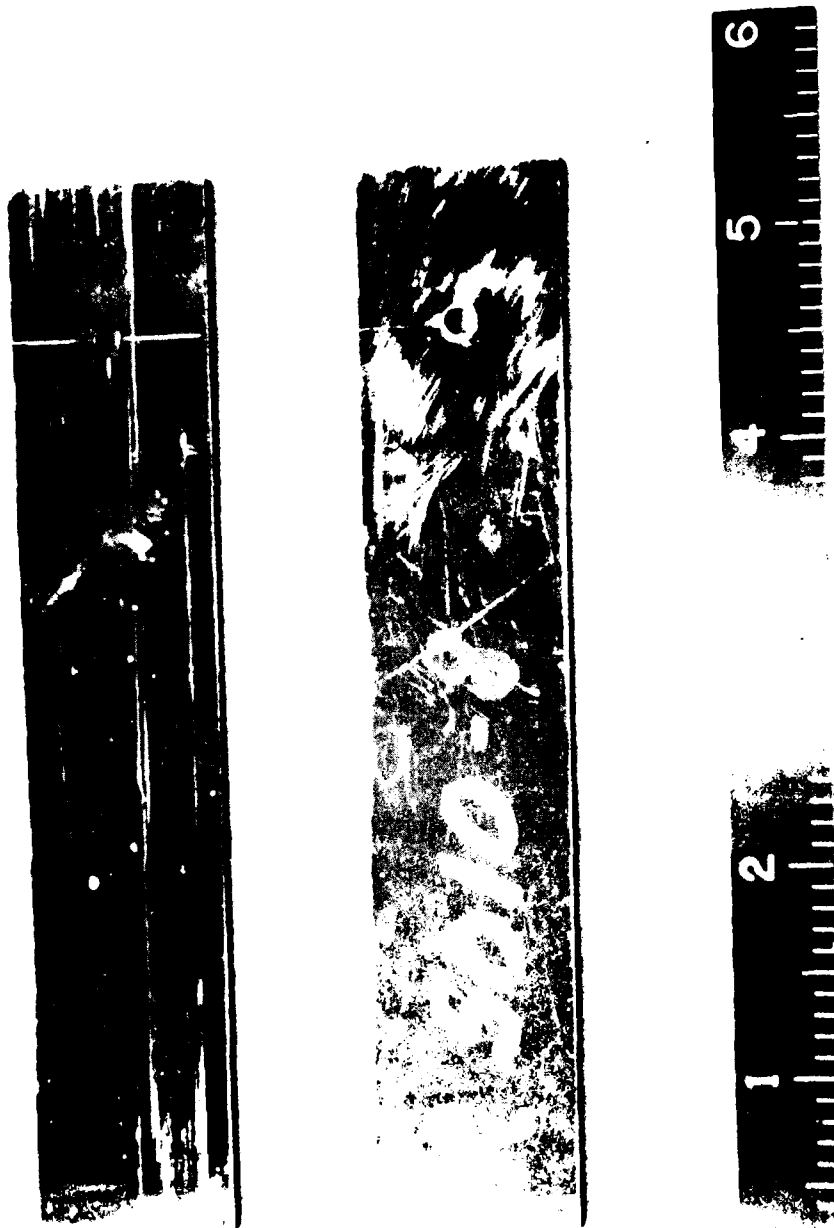
Figure 27: BOLT BEARING TEST SPECIMENS

Mechanical properties determined on the titanium clad Radel 5010 and 300P laminates included flexural, tensile, compressive, bolt bearing, and Izod impact strength. Test methods used were the same as in Task I plus ASTM D953 and D256 for bolt bearing (Fig. 27) and Izod impact strength (Fig. 28), respectively. Tests were conducted at 75 and 250°F. Results are presented in Table IV. Test results from Task I on unclad specimens are also included in Table IV, so that the contribution of the metal cladding to the performance of the composite can be determined. As expected, the titanium cladding does increase the strength and modulus of the composite compared to unclad laminates with the largest gains being registered in flexural strength and modulus.

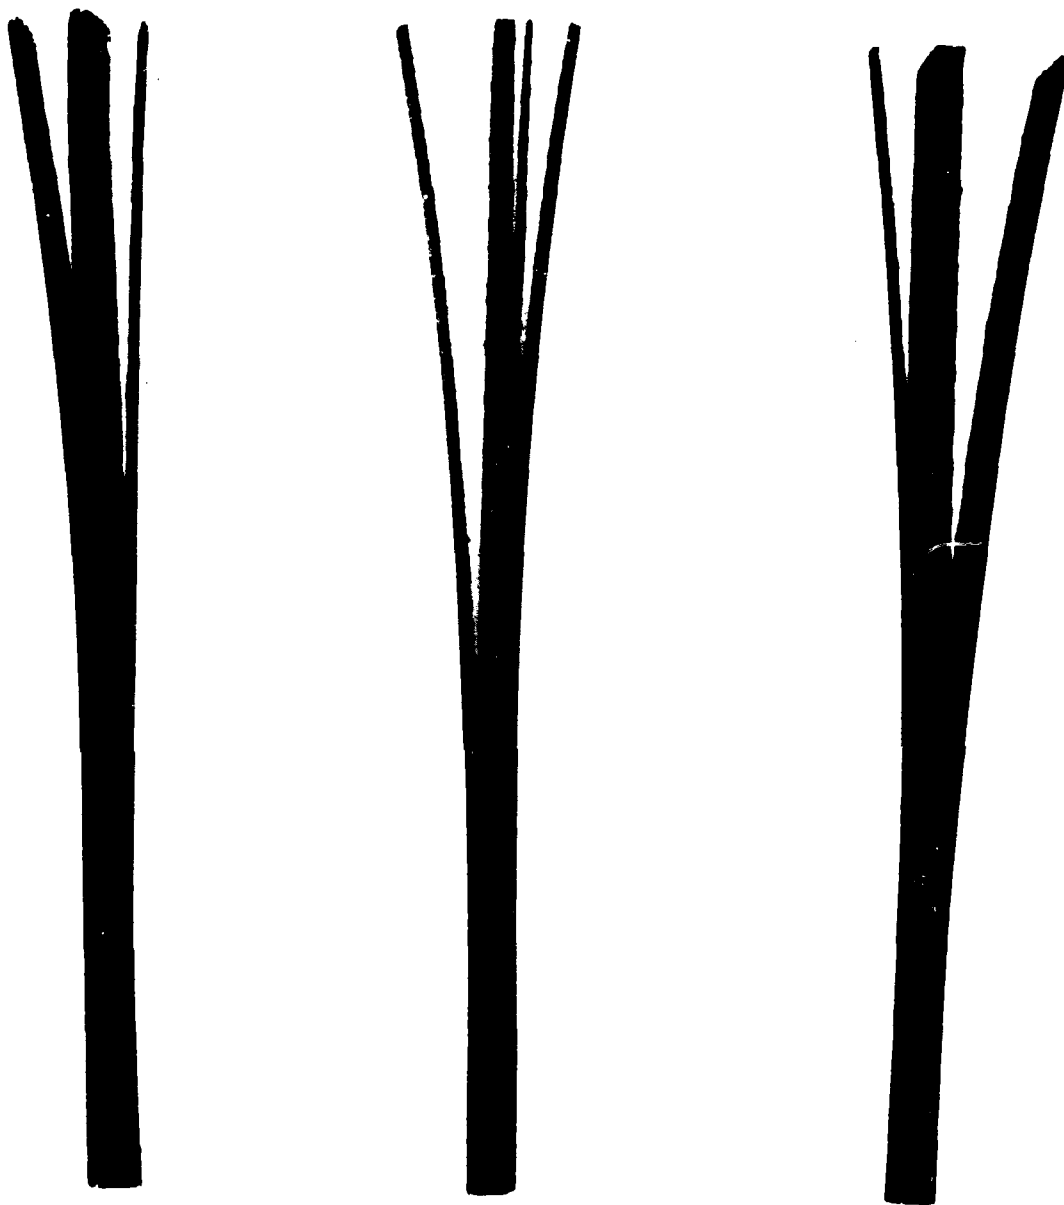
Examination of the failed specimens revealed that the failure mode was delamination within the graphite composite near either one (Fig. 30) or both (Fig. 31) metal clad facings. In all cases, the adhesive joint between the titanium cladding and graphite composite remained intact, with the delamination occurring interlaminarly between the graphite/Radel 5010 or graphite/300P plies, depending upon which laminate was being tested. The manner in which the titanium cladding and adjacent graphite ply(s) peeled away from the remainder of the specimen (Fig. 30 and 31) indicates that residual thermal stress from bonding the cladding to the graphite composite was the most probable cause of the earlier than expected failures. The cladding was secondarily bonded to the graphite-reinforced composite at high temperatures: 745°F for Radel 5010 and 640°F for 300P laminates. At these high bonding temperatures, the titanium cladding with a coefficient of thermal expansion ( $\alpha$ ) of  $5 \times 10^{-6}$  in./in./°F had expanded considerably more than the graphite composite with a  $\alpha$  near zero. Subsequently, at room temperature, the titanium cladding, trying to return, i.e., shorten, to its original length, would tend to peel away from the graphite composite as, in fact, it did (Fig. 30 and 31). Since the nonclad Radel 5010 and 300P unstressed specimens were not affected (Task I) by immersion in the same fluids as used in this

Figure 31: ENVIRONMENTAL EXPOSURE SPECIMENS - DELAMINATION BOTH SIDES

task, it is apparent that the residual stress from bonding the titanium cladding degraded the fluid resistance of the composites considerably. The problem could be circumvented by using a low cure temperature adhesive. However, since the fluid attack occurred at the exposed specimen edge, as it did in previous work (ref. 3), it appears that cladding should not be relied upon for protection from fluids unless the cladding is applied to all surfaces.

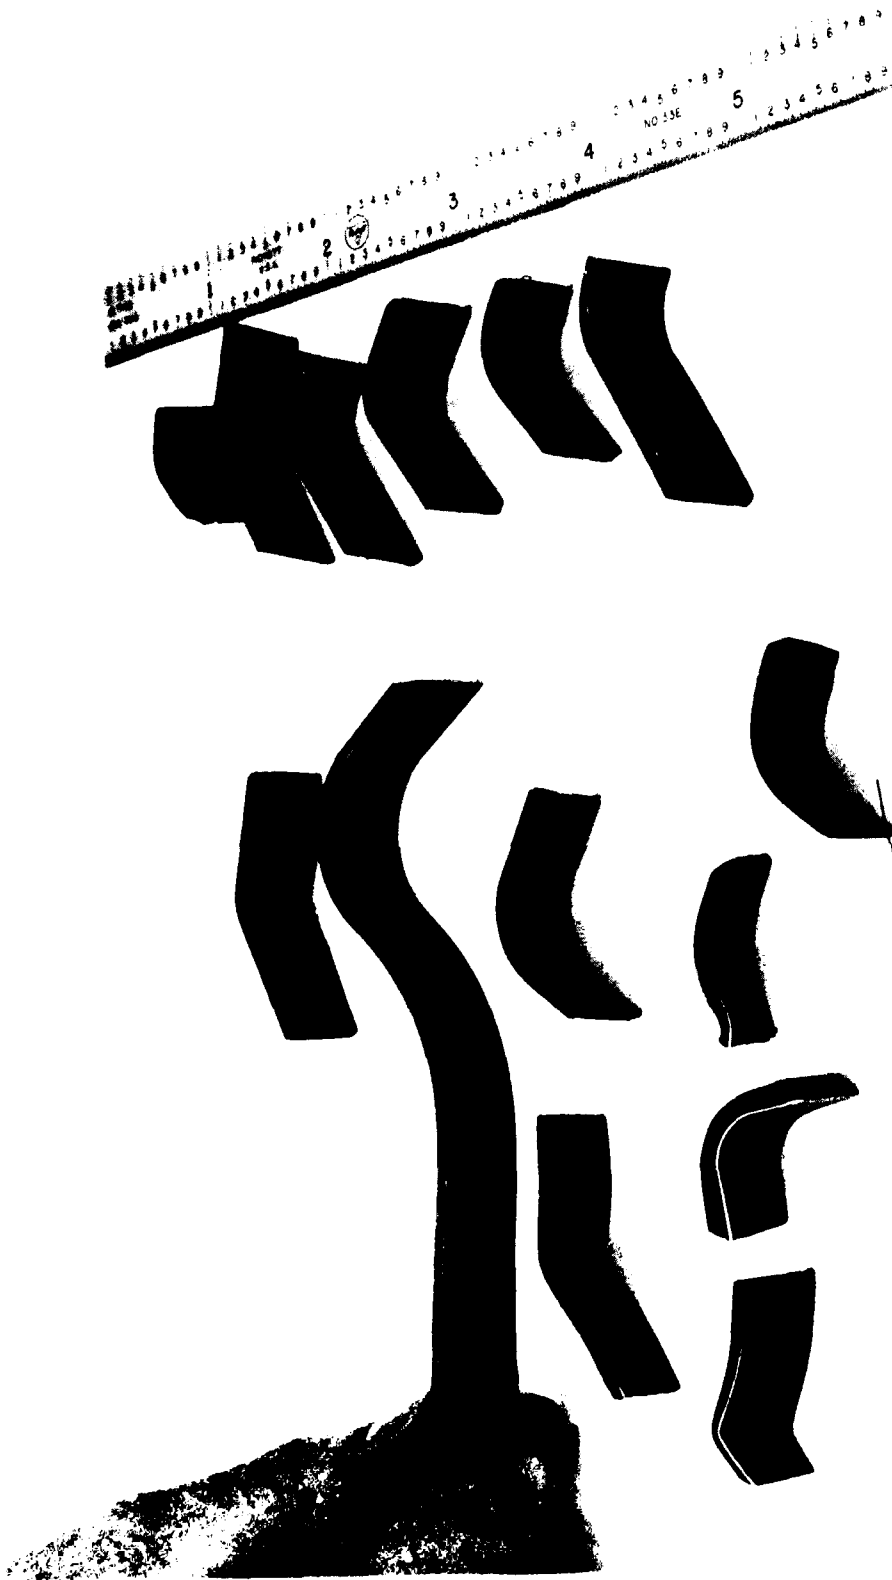
Figure 33: POSTFORMED METAL CLAD COMPOSITES

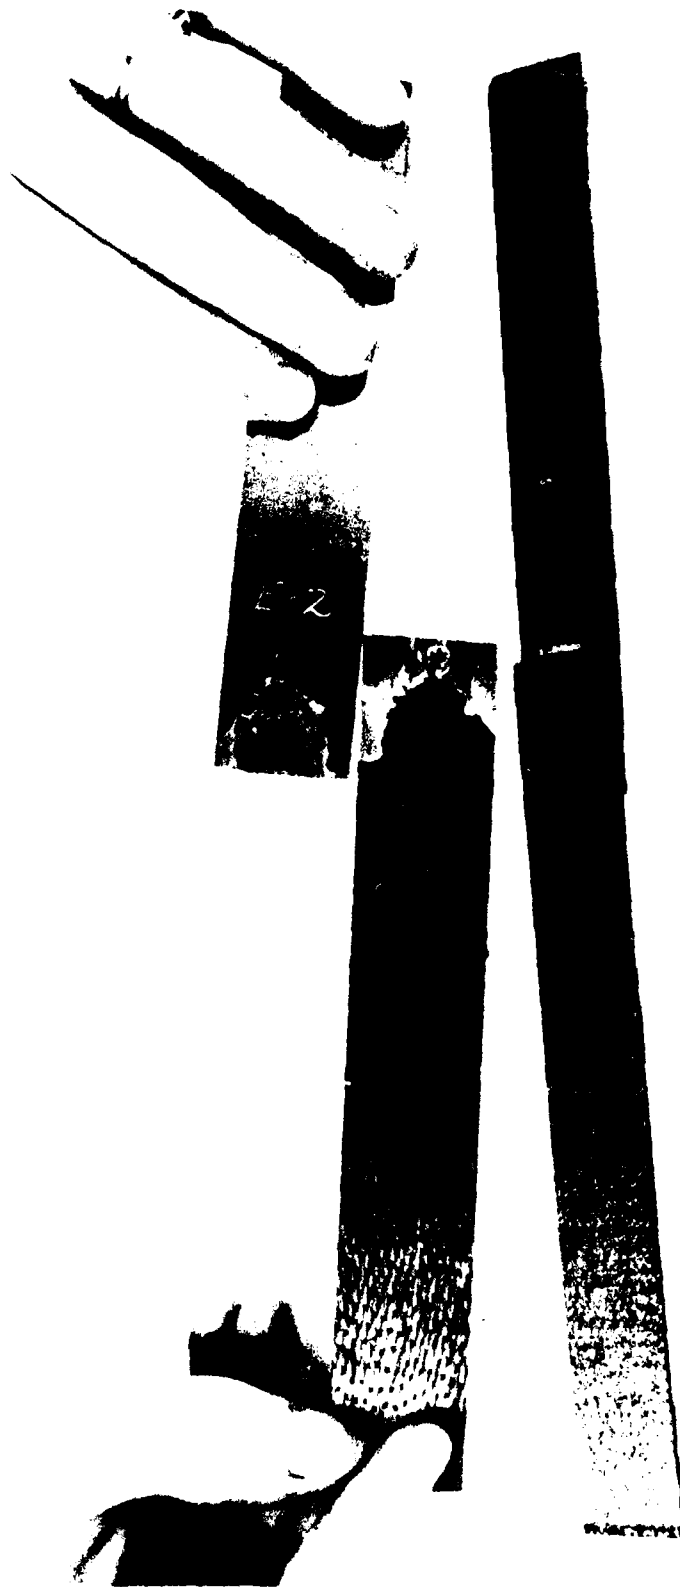
After fusion, the apparatus was disassembled and the lap joints were cut into individual specimens containing one fused spot per specimen. The specimens were then tested at 75°F. The previously established goal of 500 lb per spot was achieved whenever 0.010-inch-thick P1700 or 0.007-inch-thick Radel 5010 unsupported film was used as an adhesive. One of the specimens, after testing, is shown in Figure 35.

Figure 35: SPOT FUSION TEST SPECIMEN

Visual examination of the specimens indicated that some decompaction of the P1700 adherends occurred adjacent to the spots. This decompaction could be eliminated with refinement to the fusion process.
